Manhole Inspection Summary

Manhole # S25MM_030MH

Insp Date: **8/7/07 8:22 AM**

Location Address: **2450 MORRIS ST**

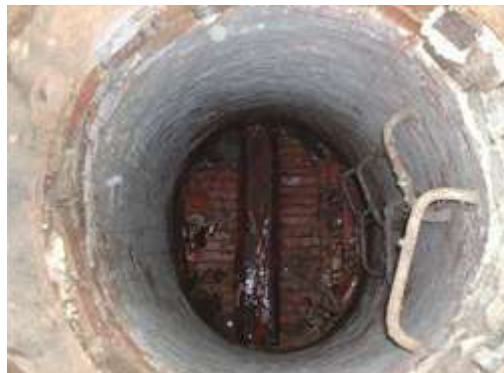
Top View

Corroded steps. Bench debris.

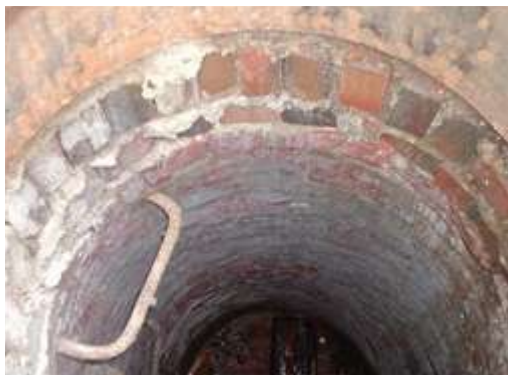
Defect

Frame leaks. Adjustment deterioration and infiltration. Corbel and Barrel infiltration - other side.

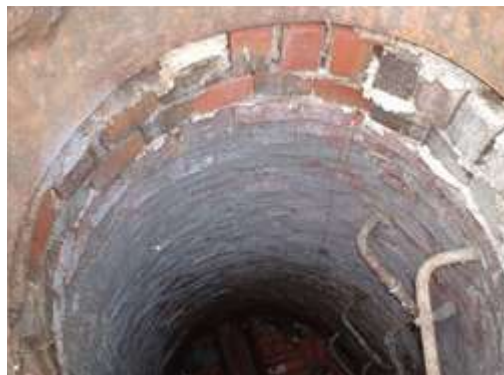
Defect

Frame leaks. Adjustment deterioration and infiltration. Corbel and Barrel infiltration.

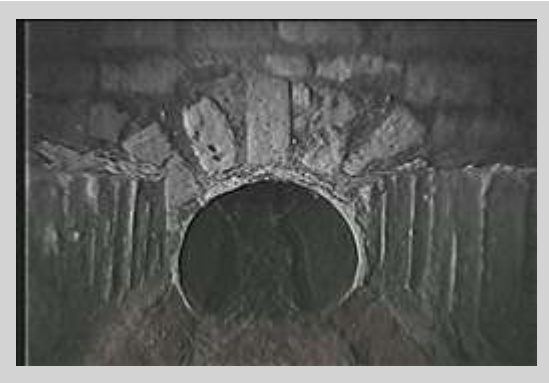
8 in. Circular Gravity Sewer Pipe Out @ 12 O'Clock

Pipe Material: **Clay** ☐ Pipe Lined

Invert Depth: **10.25** (ft.) Flow Characteristics: **Fast**

Deposits: ☒ None ☐ Mud ☐ Sludge ☐ Debris ☐ Grease

Infiltration: **None** Pipe Seal Cond: **Unknown**

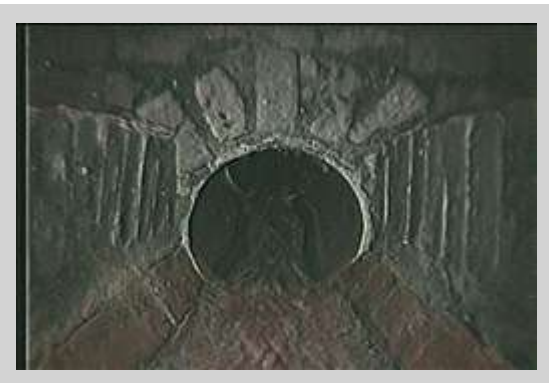
8 in. Circular Gravity Sewer Pipe In @ 6 O'Clock

Pipe Material: **Clay** ☐ Pipe Lined

Invert Depth: **9.90** (ft.) Flow Characteristics: **Fast**

Deposits: ☒ None ☐ Mud ☐ Sludge ☐ Debris ☐ Grease

Infiltration: **None** Pipe Seal Cond: **Unknown**
